Engineering Research Express

PAPER

Damage recovery for SRF photoinjector cavities

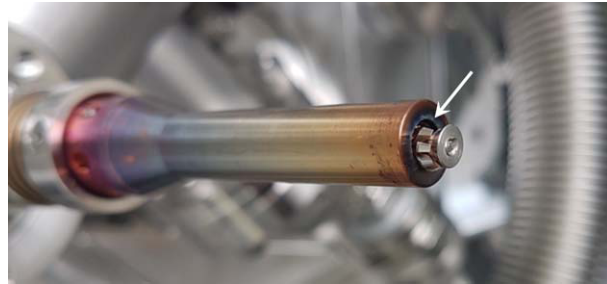
Figure 4. Copper cathode insert covered with a sputtered material (pointed with an arrow). The missing lip of the holding mechanism can be noted close to the arrow.

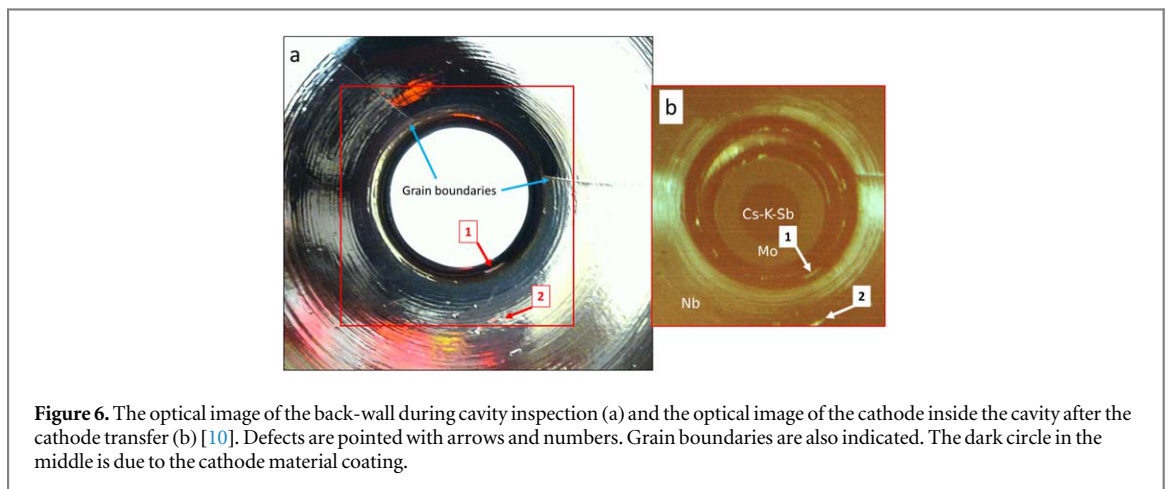
Figure 6. The optical image of the back-wall during cavity inspection (a) and the optical image of the cathode inside the cavity after the cathode transfer (b) [10]. Defects are pointed with arrows and numbers. Grain boundaries are also indicated. The dark circle in the middle is due to the cathode material coating.

After the cathode was removed, the surface optical inspection by means of a high resolution camera did not reveal any visible scratches or indents at the cathode resting position. On the other hand, high reflective spots were observed around the cathode opening. In figure 6(a) two of these spots are pointed at by the arrows and will be referred later as Defect #1 and Defect #2. The image of the same area of the cavity and the cathode shown in figure 6(b) was taken during the Gun Lab operation after the cathode transfer but before it was detached [10].

Clearly, both defects were present before the cavity test in Gun Lab. Defects were not recognised among other reflections due to poor image quality provided by a long-focus camera used to control the cathode position during the cold test.

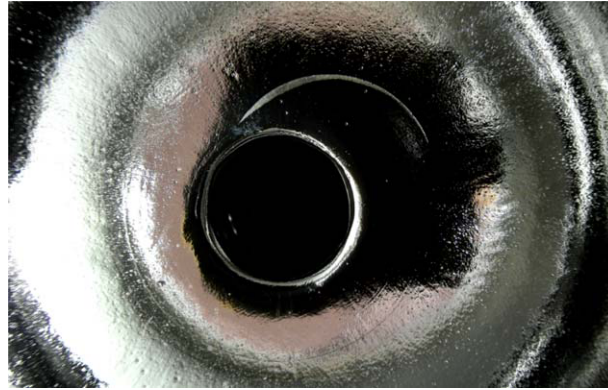
An optical image of the defects is shown in figure 7. The same replica procedure as for Gun 1.0 (see section 3) was applied to study the defect in details.

Figure 7. Optical image of Gun 1.1 back plate after collision with HPR nozzle. The dark area around the defect is a reflection of a camera.

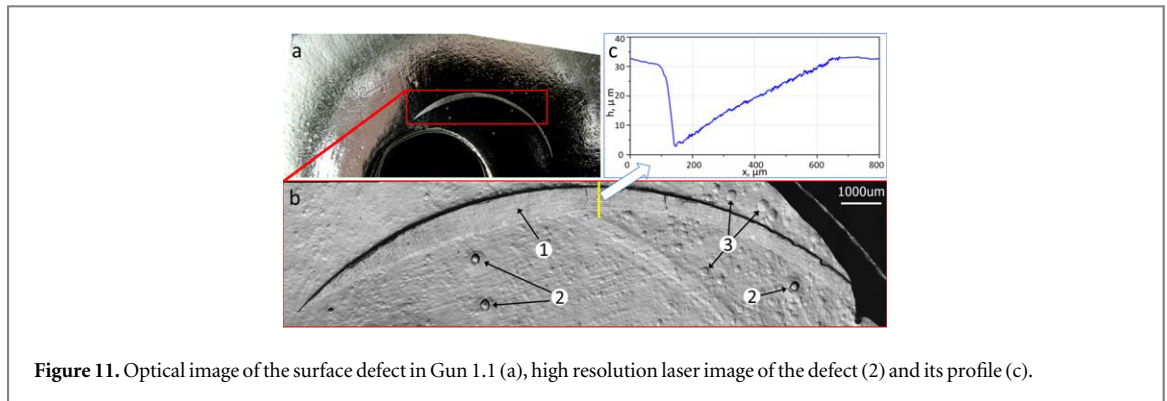
The defect caused by colliding with an HPR nozzle is shown in figure 11. The defect (1) has the diameter of 20 mm, maximum depth of 30 μm and maximum width of 0.8 mm. One can also see several point-like defects (2) which are not related to HPR nozzle collision, and typical etching pits (3) inherent in BCP process of single-crystal niobium.

Figure 11. Optical image of the surface defect in Gun 1.1 (a), high resolution laser image of the defect (2) and its profile (c).

To restore the performance of cavities it was decided to remove the defects. Several options were considered. If the standard chemical treatment was chosen at least 80 μm on average must be removed by electropolishing to sufficiently smooth the defect. It would result in an unacceptable lowering of frequency (shift of about 800 kHz), which would have removed Gun 1.0 even further off target resonance frequency. In case of buffered chemical polishing (BCP) average removal and the frequency shift would be even higher [17]. However, as both cavities were integrated with helium vessels there was no possibility to tune the cavity frequency enough after surface etching. In addition, the amount of etching required would introduce a lot of hydrogen into the niobium resulting in a possible Q-disease effect [8] and quality factor degradation.

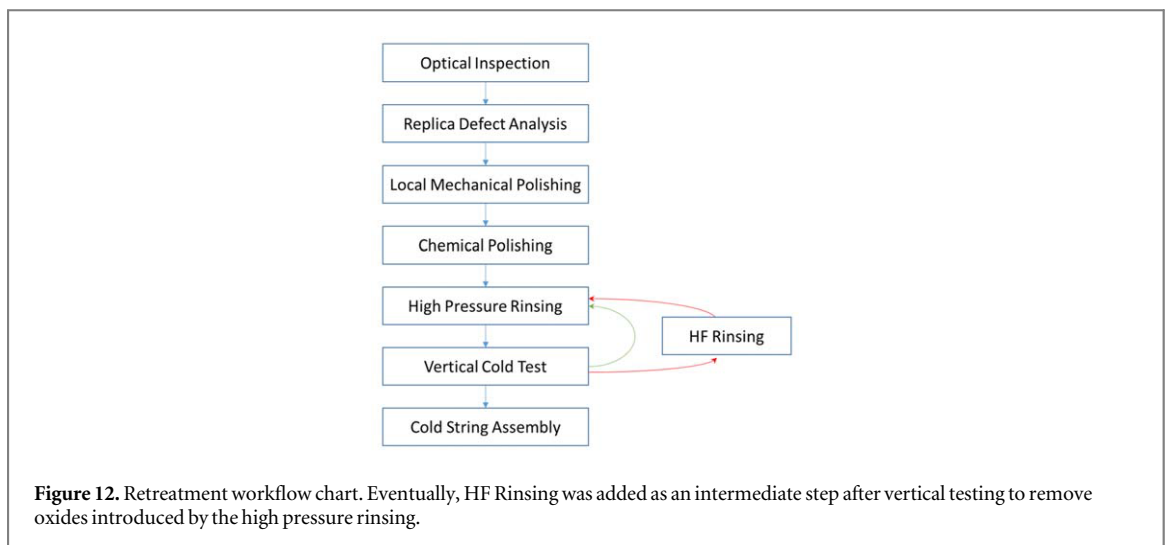
Figure 12. Retreatment workflow chart. Eventually, HF Rinsing was added as an intermediate step after vertical testing to remove oxides introduced by the high pressure rinsing.

Therefore, we decided to perform local mechanical polishing of defects followed by very light BCP (max. 10 μm) of a whole cavity and high pressure rinsing (HPR) afterwards. A workflow chart of the full retreatment procedure is shown in figure 12. Hydrofluoric acid (HF) rinsing was added afterwards to remove oxidization caused by HPR (see section 10).

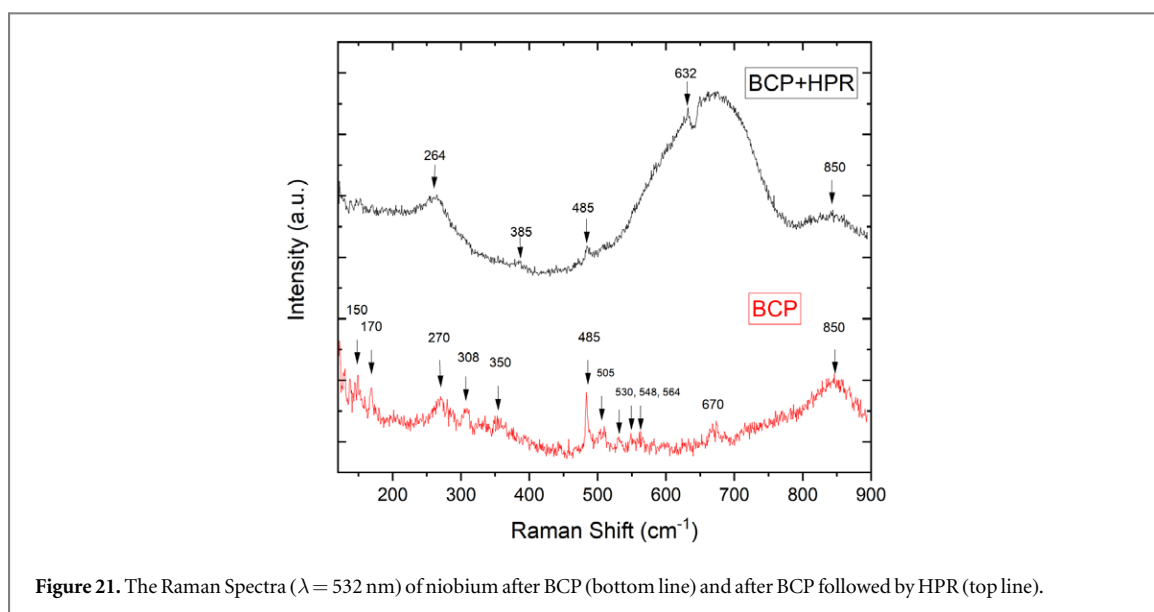
Figure 21. The Raman Spectra ($\lambda = 532$ nm) of niobium after BCP (bottom line) and after BCP followed by HPR (top line).

In figure 21 the Raman spectra of niobium surface after the standard BCP as well as the one subjected to HPR are presented for comparison. The former spectrum contains the Raman bands at 150, 170, 270, 308, 350, 485, 530, 548, 564, 670, and 850 cm^{-1} , that were reported for Nb–O modes of vibration in the slightly distorted $[\text{NbO}_6]$ octahedra as well as among the octahedra in various polymorphs of Nb_2O_5 [22–24].

The spectrum collected from the niobium coupon subjected to HPR in the area where the blue colour was the most intense, reveals the Raman bands at 264, 385, 485, 632, 670 and 850 cm^{-1} . The bands at stretching frequencies 264, 485, 850 cm^{-1} were observed in Nb_2O_5 [22, 23] while at 632 cm^{-1} was reported for both Nb_2O_5 [22] and NbO_2 [25]. One should note that in [25] the XPS spectra revealed the presence of Nb^{+5} oxidation state in the NbO_2 (Nb^{+4}) material. A broad and strong Raman band at ~ 650 eV is a typical feature of amorphous niobium oxide Nb_2O_5 or/and its hydrated form $\text{Nb}_2\text{O}_5 \cdot n(\text{H}_2\text{O})$ that possesses distorted $[\text{NbO}_6]$ octahedra, $[\text{NbO}_7]$ pentahedra and $[\text{NbO}_8]$ hexahedra as structural units [24, 26, 27].

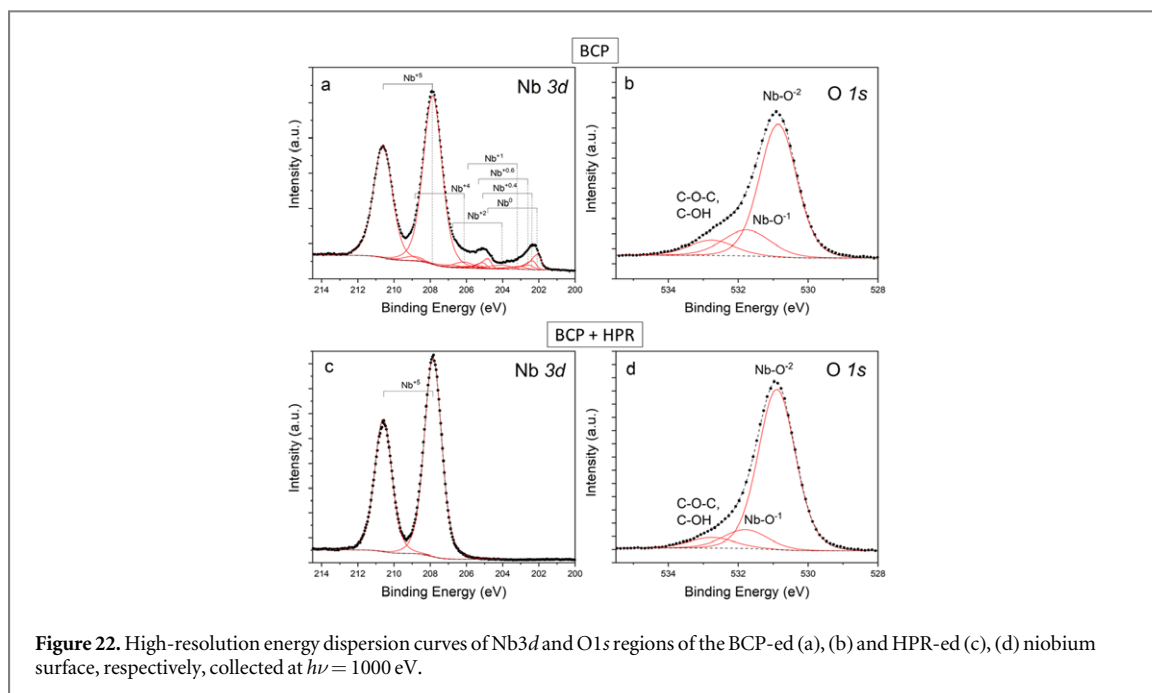
The Nb $3d$ and O 1s core-level regions of the niobium coupons processed with HPR and following an HF-rinsing are presented in figures 22(a), (b) and figures 22(c), (d), respectively. O 1s was fitted with three contributions: 530.6, 531.5 and 532.7 eV associated with O^{2-} -ions in niobium oxides, low-coordination-number O^{-1} -ions that are compensating for some deficiencies in the oxide subsurface [28], and weakly adsorbed species such as aliphatic C–O–C, etc [29], correspondingly.

Figure 22. High-resolution energy dispersion curves of Nb3d and O1s regions of the BCP-ed (a), (b) and HPR-ed (c), (d) niobium surface, respectively, collected at $h\nu = 1000$ eV.

The Nb 3d and O 1s core-levels (figures 22(a), (b)) collected from the BCP-ed niobium underscores the predominant Nb⁵⁺-oxidation state with the Nb 3d_{5/2}-binding energy at 207.85 eV and the small contributions from the lower niobium valences in the oxide film, evidently, located at the border with the metallic niobium, Nb⁰ (Nb 3d_{5/2} at 202.05 eV). For the blue niobium area after the HPR, only the doublet of Nb⁵⁺ state was pronounced with the same binding energy of Nb 3d_{5/2} as for the BCP-ed niobium (figures 22(c), (d)). Thus, the presence of Nb⁴⁺ corresponding to NbO₂ is ruled out. The FWHMs of the Nb 3d doublets corresponding to Nb⁵⁺ was slightly broader for the BCP-ed niobium surface (1.24 eV) as compared to the blue area obtained by HPR (1.15 eV). It is probably related to the Nb₂O₅-thickness difference of the two samples, and the tension that occurs at the border with metallic niobium which is disturbed in the case of BCP. The calculated 90%-information depth (the depth normal to the surface from which 90% of the detected signal originates [30]) for our experimental condition is 4.64 nm ($h\nu = 1000$ eV).
