# Line defects in epitaxial silicon films grown at 560°C

We present an investigation of line defects in epitaxially grown silicon layers using Secco defect etching and transmission electron microscopy (TEM). 1  $\mu\text{m}$  thick layers were deposited onto Si (100) wafers at a substrate temperature of 560°C using electron cyclotron resonance chemical vapour deposition (ECRCVD). Defect etching reveals a variety of etch pits related to extended defects. A detailed analysis of the orientations and shapes of etch pits related to line defects is carried out. Using this information it is then possible to assign different types of etch pits to line defects observed by TEM. The investigations show, that one type of defect are extended dislocations parallel to  $\langle 112 \rangle$ , while the direction of two other types are  $\langle 110 \rangle$  as well as  $\langle 314 \rangle$ , a direction uncommon for line defects in silicon.

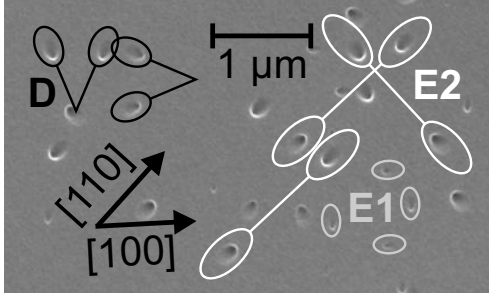
Fig. 1. Topview SEM image showing the different types of elliptical etch pits observed after Secco etching. The lines connecting E2 and D pits indicate defect pairs as discussed in the text.

The elliptical etch pits found in our samples can be put into three categories (E1, E2, D) as indicated in the overview SEM image of a Secco etched surface of an epi-layer shown in Fig. 1. The properties of the different types of etch pits and their correlation to defects observed in TEM images will now be discussed.

E2 are elliptical etch pits whose main axis is approximately 300 nm long and aligned parallel to the  $\langle 110 \rangle$  directions. This shows that the direction of the underlying defect can be written in the form  $\langle 11z \rangle$ . As indicated in Fig. 1 these etch pits are often found in pairs whose two partners lie on a  $\langle 110 \rangle$  line. The separation of the two partners,  $r_{E2}$ , depends on the thickness of the epitaxial layer,  $d_L$ , as shown in Fig. 3. Note that the vertical line at each data point represents the spread of  $r_{E2}$  observed for each sample. The linear dependence observed in Fig. 3 indicates that the defect pairs start to grow in approximately the same depth below the surface. Assuming that this is the epi-Si/c-Si interface, it is possible to get an estimate for the  $Z$  component of the defect orientation. The lines added to the graph give the calculated values of  $r_{E2}$  for line defect pairs that start to grow at the epi-Si/c-Si interface into the given directions. It becomes obvious from Fig. 3 that the experimental data are best described assuming a direction of  $\langle 112 \rangle$ . However, the observed values of  $r_{E2}$  lie on or slightly below the predicted behaviour for defects with  $\langle 112 \rangle$  directions.

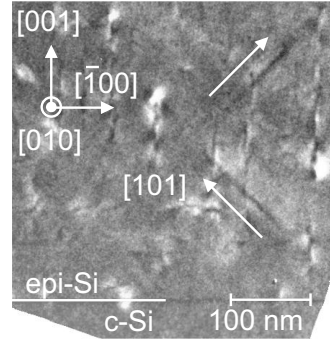
Fig. 2. Cross-section TEM image of defects responsible for the E1 etch pits. The line direction of the defects is  $\langle 110 \rangle$ .

shape is typical for line defects penetrating the surface at some angle. From the direction of the etch pits on the (001) surface we can conclude that the direction of the underlying defects are of the form  $\langle 10z \rangle$ , where  $z$  indicates that the component in growth direction cannot be deduced from this topview image. Cross-section TEM images of a sample with a high density of E1 prepared in a (010) plane can provide this information. In Fig. 2 line defects in  $\langle 101 \rangle$  directions can be observed, as indicated by the arrows. Note that the vertical lines also visible are due to defects of the same kind which lie in the (100) plane perpendicular to the (010) plane. Since no other defects with directions of the form  $\langle 10z \rangle$  were observed, we deduce, that this defect is the cause for the E1 etch pits.

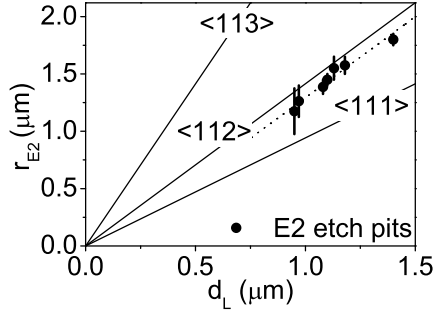
Fig. 3. Experimentally determined separation,  $r_{E2}$ , (dots) between the partners of the E2 etch pit pairs on the layer thickness,  $d_L$ . The solid lines represent the separation calculated for defect pairs that grow into the given directions starting at the epi-Si/c-Si interface. The dotted line is a fit to determine the average distance of the "kink" to the interface (see text).

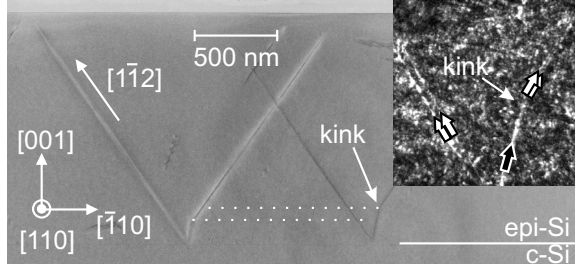
Fig. 4. TEM image of V shaped defects responsible for the E2 etch pits. The line direction of the defects is  $\langle 112 \rangle$ . The dotted lines indicate the plane parallel to the epi-Si/c-Si interface where the kink is observed for the two defect pairs. The inset shows a more detailed image of the region around the kink.

To get more insight into this behavior, TEM investigations were performed on a sample that exhibits a high E2 density. Fig. 4 shows a TEM image of two defect pairs where both partners lie exactly in  $\langle 112 \rangle$

directions. Near the interface the direction of one of the two line defects is tilted towards the surface normal. The distance from the interface where this "kink" occurs is not fixed but varies from pair to pair as indicated by the two dotted lines. The presence of this kink will therefore result in a slightly smaller  $r_{E2}$  than expected for a pure  $\langle 112 \rangle$  direction. Taking this kink into account, the data in Fig. 3 can be fitted with a linear function (dotted line) from which a mean distance of the kink from the interface of about 230 nm can be estimated. This is in good agreement with what is found in Fig. 4. These defects therefore explain the dependence of  $r_{E2}$  on  $d_L$  and also its variations and can be identified as the origin of the E2 etch pits.

To get more insight into the region around the kink, a more detailed image is shown in the inset of Fig. 4. For this image the sample was slightly tilted, revealing that the defect is a single line in the region between the kink and the interface (black arrow), but a set of two parallel lines in the region, where the direction is  $\langle 112 \rangle$  (white arrows). In the region between the kink and the interface the Burgers vector (b) was determined to be perpendicular to the dislocation line

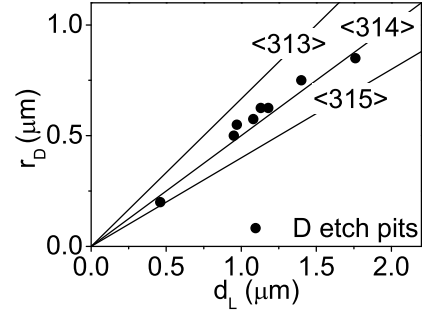
Fig. 5. Dependence of the separation,  $r_D$ , between the partners of the D etch pit pairs as a function of the layer thickness,  $d_L$ . The lines give the separation calculated for defect pairs that grow into the given directions starting at the epi-Si/c-Si interface.

The D etch pits are elliptically shaped, with their main axis being  $\sim 300$  nm long and tilted by  $\sim 20^\circ$  with respect to the  $\langle 100 \rangle$  direction. From this angle the direction of the underlying defect can be estimated to be of the form  $\langle 31z \rangle$ , which corresponds to an angle of  $18.4^\circ$  with respect to  $\langle 100 \rangle$  (the directions  $\langle 41z \rangle$  and  $\langle 21z \rangle$  would result in an angle of  $14^\circ$  and  $26^\circ$ , respectively). These etch pits also appear in pairs as indicated in Fig. 1. The separation of the two partners depends on the layer thickness as in the case of E2 (Fig. 5). Therefore, the Z component of the direction of the underlying defect can be determined by the same procedure as in the case of E2. Fig. 5 shows the separations,  $r_D$ , calculated for different orientations of the defect. Obviously, the experimental data (dots) are

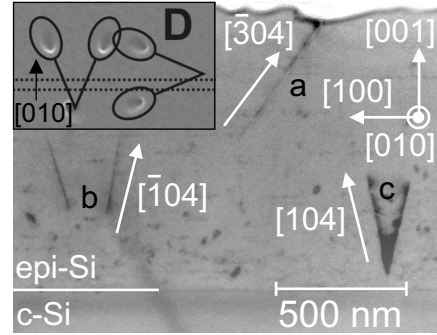
Fig. 6. TEM image of defects responsible for the D etch pits. The line direction of the defects is  $\langle 314 \rangle$ , the projections on the (010) plane are therefore  $\langle 304 \rangle$  and  $\langle 104 \rangle$  oriented. The inset shows a detail from Fig. 1. The dotted lines indicate the boundaries of a (fictitious) TEM sample prepared in the (010) plane.

best described assuming that the orientation of the defects is  $\langle 314 \rangle$ . This is supported by the TEM image shown in Fig. 6 which was taken on a sample prepared in the (010) plane. Since  $\langle 314 \rangle$  does not lie in a (010) plane and the TEM sample has a finite thickness only parts of the defect lines are present in the thin slice. For better visualisation the inset shows a detail from Fig. 1, where the dotted lines indicate the boundaries of a (fictitious) TEM sample prepared in a (010) plane. Depending on the orientation of the D pairs, either both or just one partner are present in the sample. In the TEM image (parts of) three defect pairs are visible (a-c). In two cases (b and c) both partners are visible, while the pair "a" is oriented perpendicular to b and c, so that only one partner is visible. The projections of the direction estimated for the D-Pairs ( $\langle 314 \rangle$ ) onto the (010) plane are indicated by the arrows. These directions agree well with the directions of the defects, so that they can unambiguously be identified as the cause for the D etch pit pairs.
